# TRIAL OF GROUND PENETRATING RADAR TO LOCATE DEFECTS IN TIMBER BRIDGE GIRDERS

Engineer (Concrete Technology),  
Structures Division, RS&E Group, [Queensland Department of Main Roads](#)

## Abstract

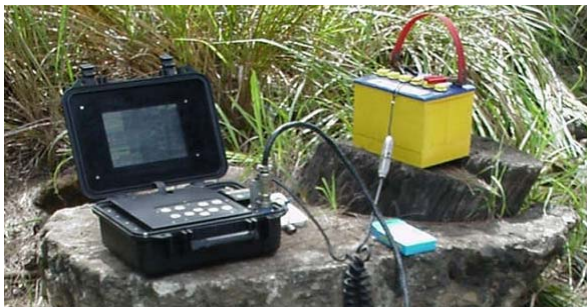
**Figure 6 - SIR2000 control unit powered by a car battery**

The GPR system used was a GSSI SIR 2000 with a 1.2GHz ground coupled dipole antenna. The system was powered in the field by a car battery. The SIR2000 control unit is shown in Figure 6.

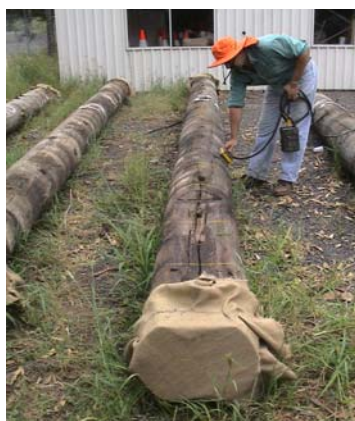
**Figure 7 - GPR investigation of Purga Creek Girders**

Survey runs consisted of sliding the antenna along the length of the girder – see Figure 7. Each survey run was completed in around a minute with around 30 seconds to set up for the next run.

Passes were undertaken on each girder in the “2 o’clock” and “10 o’clock” orientations, as these would avoid bolts on an insitu girder. Runs were first undertaken in 8-bit format and later repeated using 16-bit format data. These results were very similar indicating a high level of repeatability.

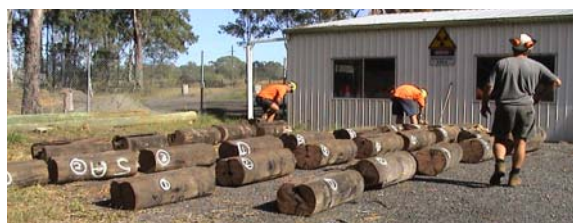
**Figure 8 - Purga Creek Girders are cut up**

To assess the validity of these predictions the girders were cut with a chainsaw at one-metre marks and the defects were located. Where the GPR data indicated features lay between the metre marks additional cuts were made. The dissected girders are shown in Figure 8.

Overall there was an excellent correlation between the location and size of defects predicted and those found after dissecting the girders. A variety of defect types were detected including piping, cracking and rot.

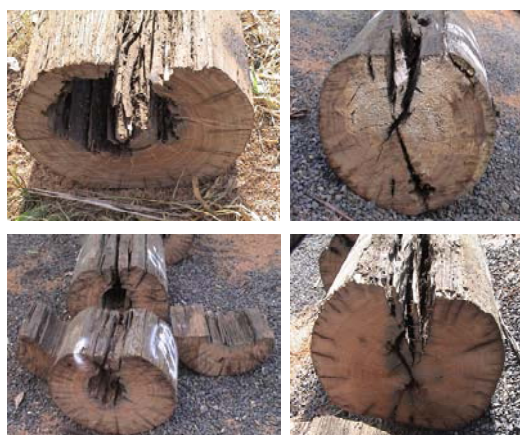
**Figure 9 – Purga Creek Girder defects**

Some of the internal defects located by the GPR investigation are shown in Figure 9. An example of the processed GPR data, defect predictions and corresponding photographs for one of the girders is shown in Appendix A.

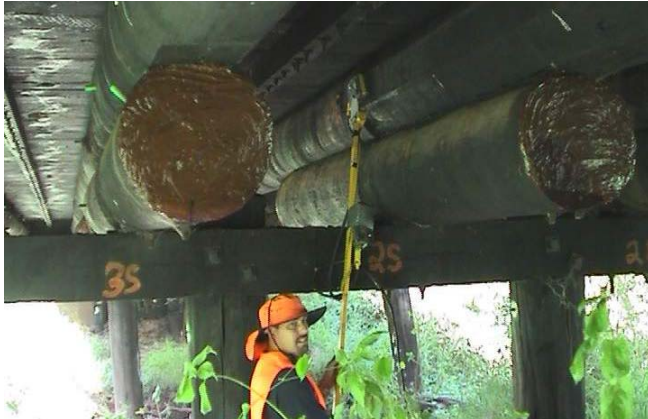
**Figure 10 - GPR investigation of Redbank Creek (Crossing #3) Bridge**

The same GPR system used for the Purga Creek investigation was also used for the Redbank Creek investigation. To reach the girders the GPR antenna was mounted on a fibreglass pole – see Figure 10.

Horizontal and vertical passes were undertaken on each internal girder. As bolts get in the way, only one pass was undertaken on each external girder, aligned in between the rows of bolts. Each run took around a minute to complete and 30 seconds to set up for the next run.

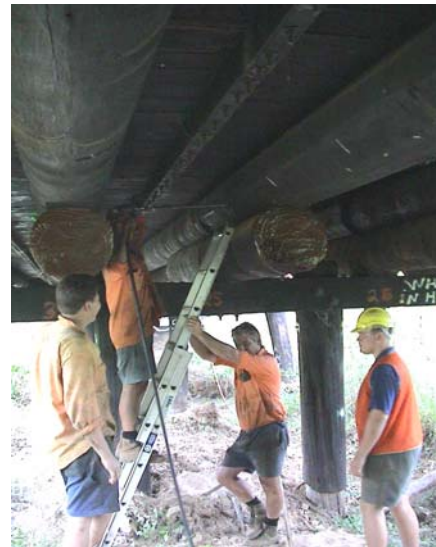
**Figure 11 - Drilling investigation of Redbank Creek (Crossing #3) Bridge**

Drill locations were selected onsite by the Author based on the radargram output. The defect predictions were read aloud before each drill hole was undertaken. Areas predicted to contain large defects, small defects and no defects were drilled to test the predictions. Figure 11 shows the drilling investigation underway.

In general there was an excellent correlation between the GPR predictions and the drilling survey findings.

Every location where a major feature was predicted one was found, and every location predicted to be sound was confirmed by the drilling. The majority of smaller defects predicted by the GPR were also found by drilling. In total 35 drill holes were undertaken.
