OUTDOOR RECREATION FACILITIES IN NATURAL ENVIRONMENTS

Bill Lawson¹ and Graeme Booth²

¹Principal, Sinclair Knight Merz

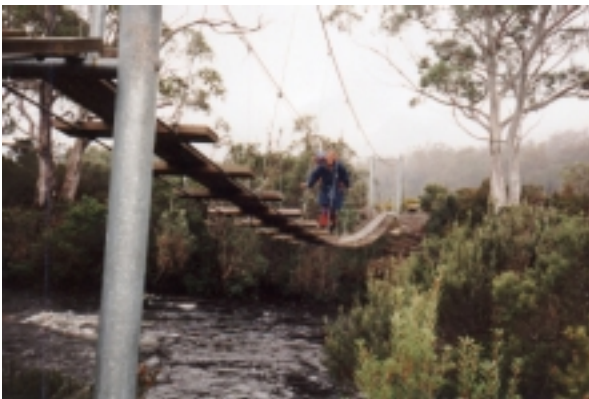
Figure 1 Most structures are simple in engineering terms but some are more complex

The structures are not, in the main, structurally complex.

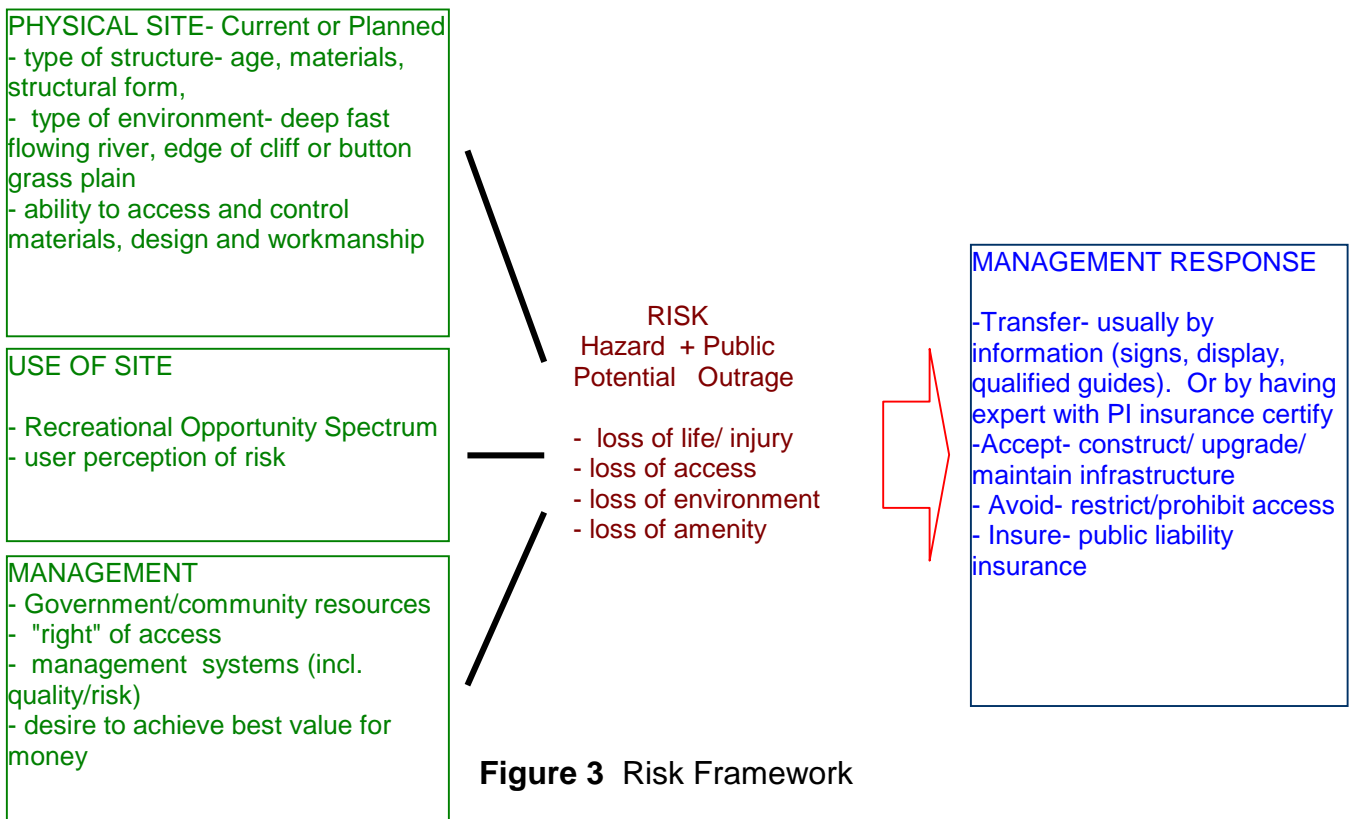
Managers are faced with a risk management task within an environment of limited financial resources. Figure 3 shows that the environment for risk is created by:

- i. the physical site itself,
- ii. the use is made of it by visitors, and
- iii. unsafe barrier design.

Figure 3 Risk Framework

The range of actions available to the land manager are shown on the right of Figure 3. All of them can be handled within an asset management context as described below.

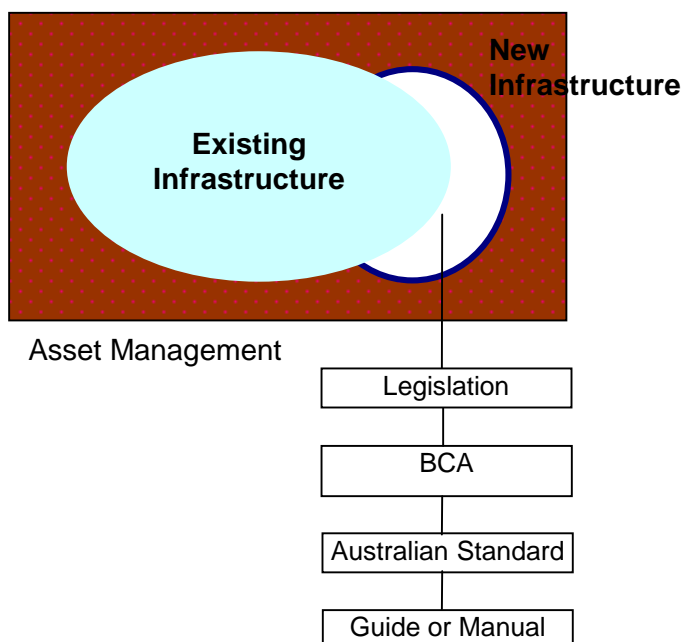
Figure 4 shows a framework within which responsible land managers can undertake asset management.

Figure 4: Framework for management of walking track assets

As figure 4 shows, the BCA and the current legislative framework only covers new facilities. Most of the asset stock at any point in time is not “new”.
